The 1992 Roermond earthquake, the Netherlands: earthquake engineering

Jack G. Bouwkamp

Institute of Steel Construction, Technical University of Darmstadt, Alexanderstrasse 7, 64283 Darmstadt, Germany

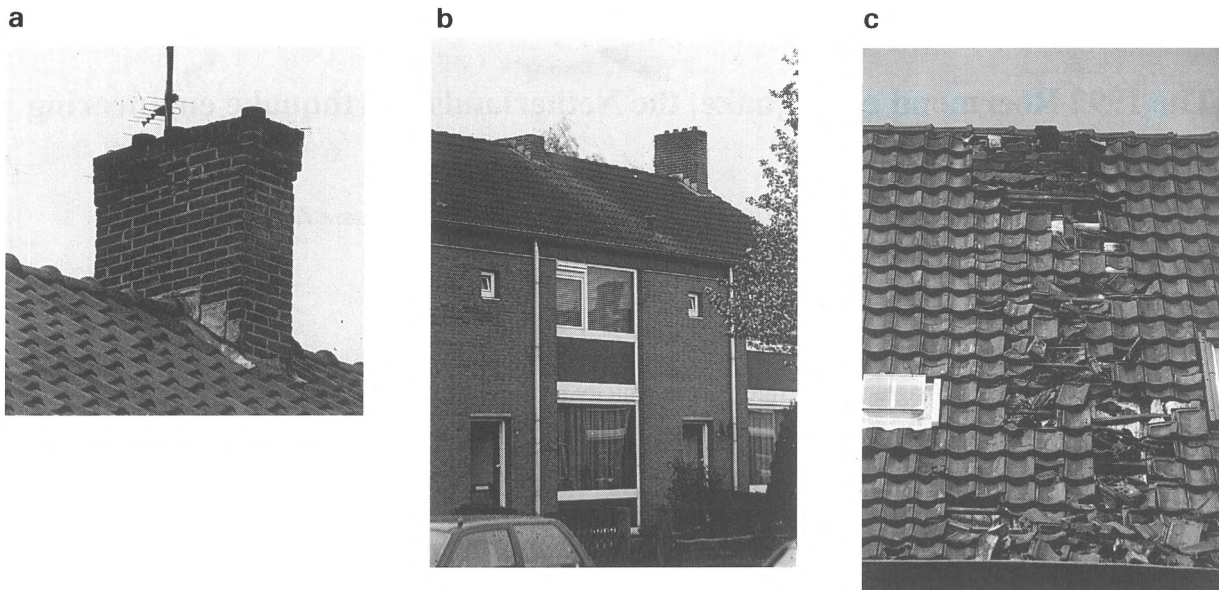
Fig. 1. Typical observed chimney damage due to the Roermond earthquake of April 13, 1992. a) torsional deformation, b) partial collapse, c) complete collapse.

Specifically, as expected, the damage was restricted to failure of brick masonry chimneys and parapets (Fig. 1). Damage to chimneys typically showed horizontal cracking of the masonry above the roof level. In a number of cases a horizontal offset of the uppermost portion of the chimney could be observed. In only a very few cases the upper chimney portion had actually toppled over and damaged the tiled roofs. Other, less frequent damage could be observed as partial collapse of gable end-walls which had been inadequately tied to the wooden roof structure. In only a limited number of instances could significant diagonal shear cracking of exterior masonry walls be noted. Local damage to masonry due to pounding of immediately adjacent buildings could also be observed in a few cases.
