## Observations of damage ratios to buildings in the epicentral region of the 1992 Roermond earthquake, the Netherlands (extended abstract)

J.W. Pappin<sup>1</sup>, A.R. Coburn<sup>2</sup> & C.R. Pratt<sup>3</sup>

*Key words:* MSK intensity, earthquake damage

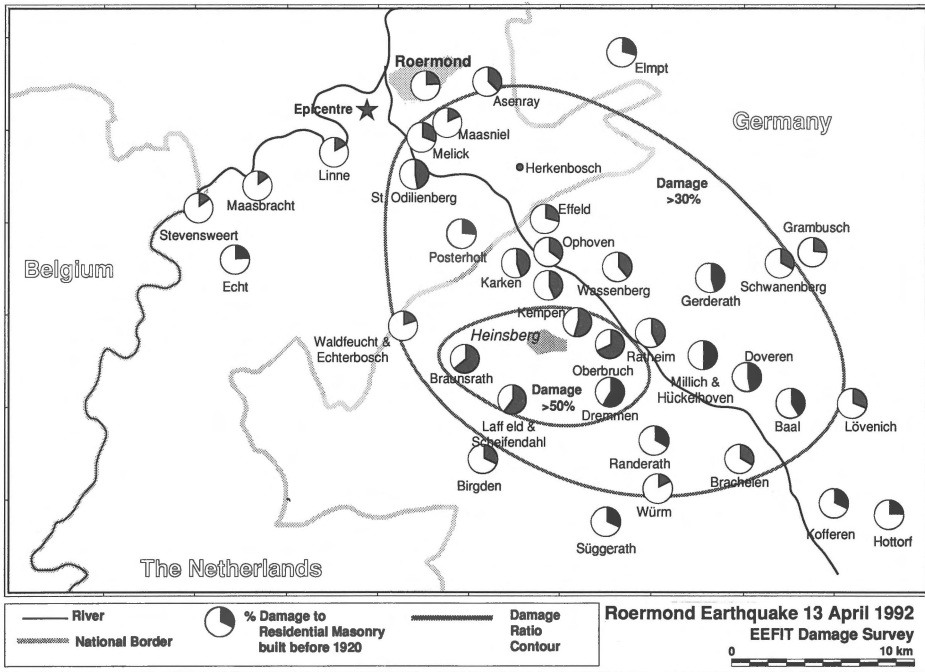
The results of the survey for damage ratio of type RM20 buildings with at least damage level D1 are shown in Fig. 1. The greatest damage ratio was observed in Oberbruch, about 4 km east of Heinsberg in Germany, with 67% of type RM20 buildings experiencing at least slight damage. A further 18 villages, generally within 10 km of Heinsberg, had damage ratios over 30%. It must be emphasised that the EEFIT team did not visit Herkenbosch which clearly experienced significant damage. It is therefore not known whether Herkenbosch would plot as a local greater damage ratio or whether it would conform to the pattern shown in Fig. 1.

In terms of the MSK intensity scale we have assigned a maximum value of VI defined as damage D1 to a few masonry buildings and to most rural and field stone houses. This intensity extends out to about the 30% damage ratio contour and encloses an area of about 300 km<sup>2</sup>. It is interesting to note that in Roermond, which probably experienced the greatest damage cost because of its relatively large population, only about 22% of type RM20 buildings were observed to experience slight damage or worse.

Figure 1 indicates that the centre of damage does not coincide with the recorded epicentral location. Whilst there may be a geological reason for this, it is also possible that there is a systematic variation in the level of building maintenance across the area of damage. The level of complexity raised by this possible variation is beyond the scope of this study, however.

Fig. 1. Damage to residential masonry following the 1992 Roermond earthquake. Percentages as in Table 2.
