LANDSLIDING IN THE CRATI BASIN, CALABRIA, ITALY

J.J. NOSSIN¹⁾

ABSTRACT

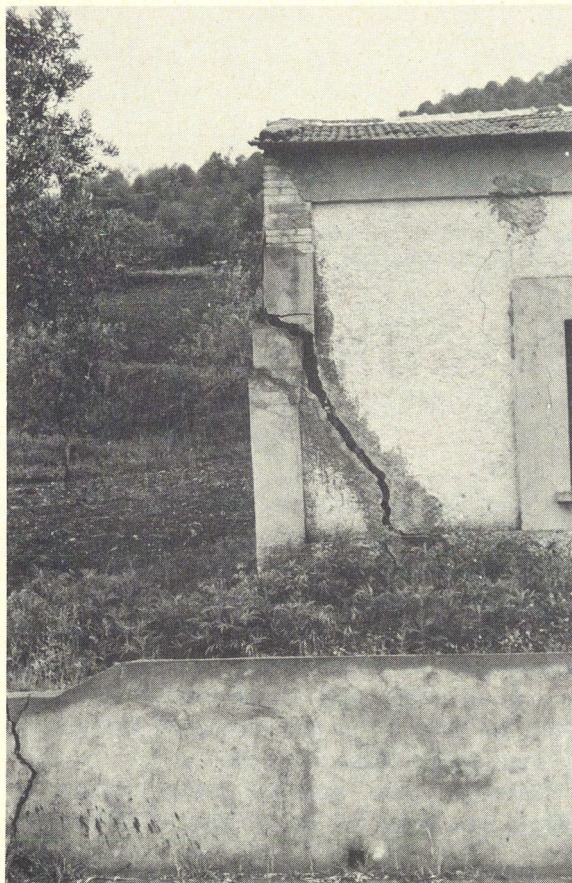
Fig. 1
House damaged as a result of sliding in marly clay.

lines and damage property, buildings, roads and arable lands with great frequency (fig. 1). It seems worth while to assemble criteria that afford a timely recognition of unstable slope zones, in order to reduce the peril that arises out of interference in these slopes. The present paper is based on observations in the Upper and Middle Crati basin during 1968, '69 and '70, in the Province of Cosenza, in the south-Italian region of Calabria.

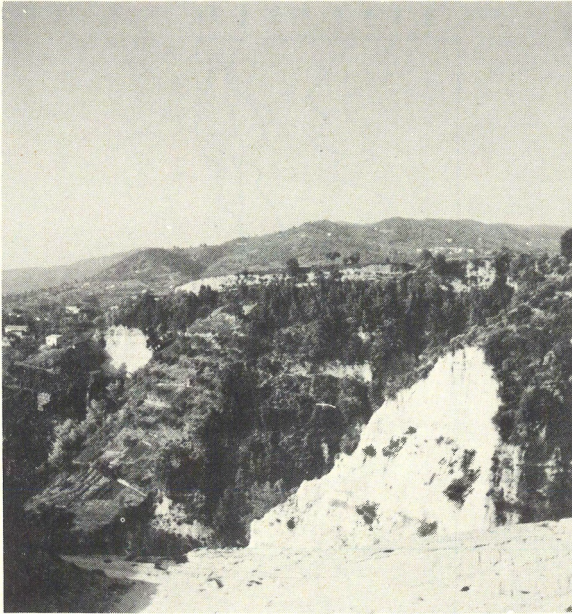
Fig. 4
Ravines in Tertiary basin deposits.

area. Intensive ravining is noted in practically all of the Tertiary sandy and gravelly deposits (fig. 4), whereas the fault-bounded clay areas in the west manifest themselves as a series of actual depressions.

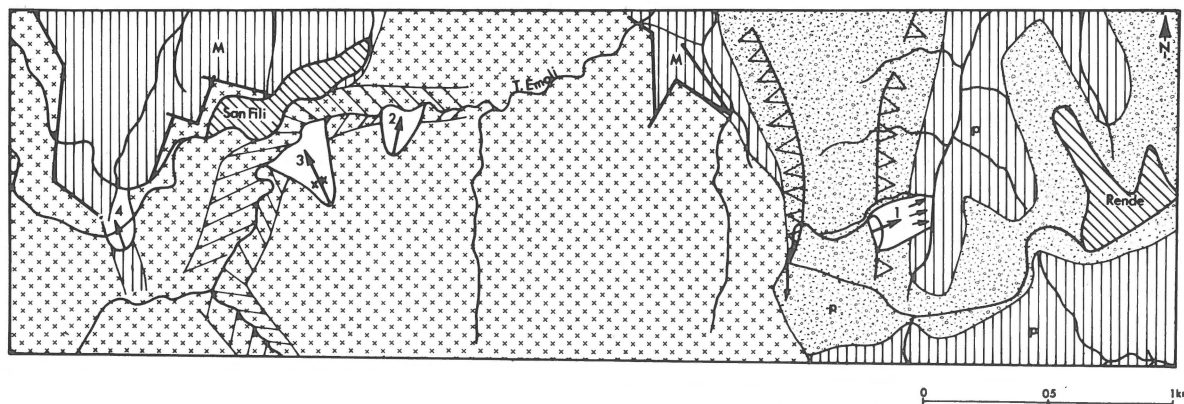
Fig. 7
Map showing landslides and geological setting in Rende-San Fili area (cf. fig. 2).

Opposite the village of Rende, a landslide occurs which has resulted in spectacular road damage (figs. 7 & 8).

- the occurrence of bands of clay interbedded in a sequence of Calabrian sands and sandstone in a semi-consolidated state, dipping 7° to the northeast. Above the clay layers, the profile of the slope face is waterlogged.

- b. exposure of this sequence in an erosional escarpment (due to undercutting as a result of rejuvenation mentioned above), facing northeast and east.

The cause of the actual sliding is the cutting in the slope face for a new road connecting Rende with Marano. The slope has failed where the road excavation intersects with the clay bands in the waterlogged profile. The slide can be typified as a pelitic rock slide. The first movement took place in 1969 after the excavation work, resulting in repairable damage. In 1970, the slide was re-activated, resulting in the complete destruction of the road.

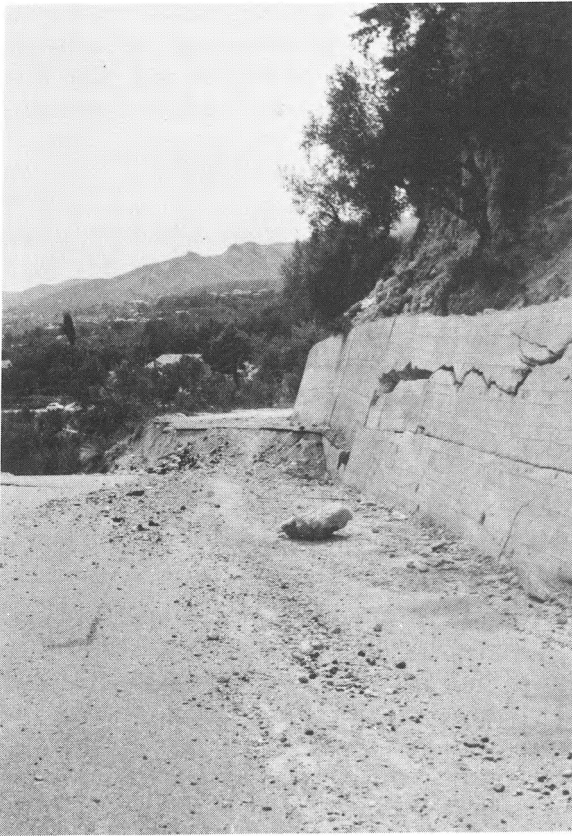
Fig. 8
Road destruction as a result of landslide opposite Rende (cf. fig. 7).

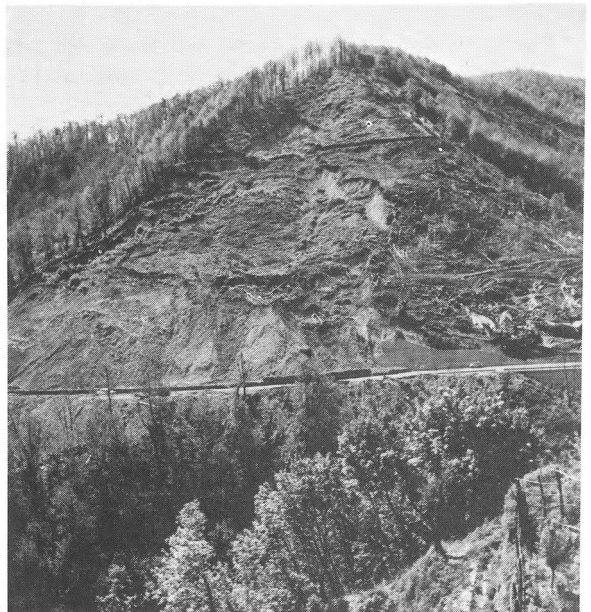
Fig. 9
Major landslide (No 3) opposite San Fili. Note that forest was cut *after* slide in the course of corrective measures.

The gradients are about 40% and 60% for slide 2 and 3, respectively, corresponding to average terrain slopes of 22° and 31° . Here, too, the slid and ruptured surface of the slide shows large deviations from this figure.

- The cause of the slope instability* is, in both cases,
- the undercutting at the foot of the slope by the T. Emoli, resulting from rejuvenated incision,
 - the loss of coherence in the crystalline metamorphic rocks, that in both instances form the slope, due to their having been crushed in the tectonic past, and to the nearness of the fault contact between the Tertiary basin deposits and the crystalline metamorphics. In slide 3, the larger of the two, a spring horizon is cut about 20 meters below the crown.

The cause of the actual sliding is, in both cases, cutting in the slope for the new road. It is of interest to note that the failed slopes were under forest prior to the road cutting, and the slope failure took place in spite of the forest cover. The slides can be characterized as rock debris slides (figs. 7 & 9). First movements took place in 1969, after the road had been completed. Movements renewed in 1970, causing extensive road damage.

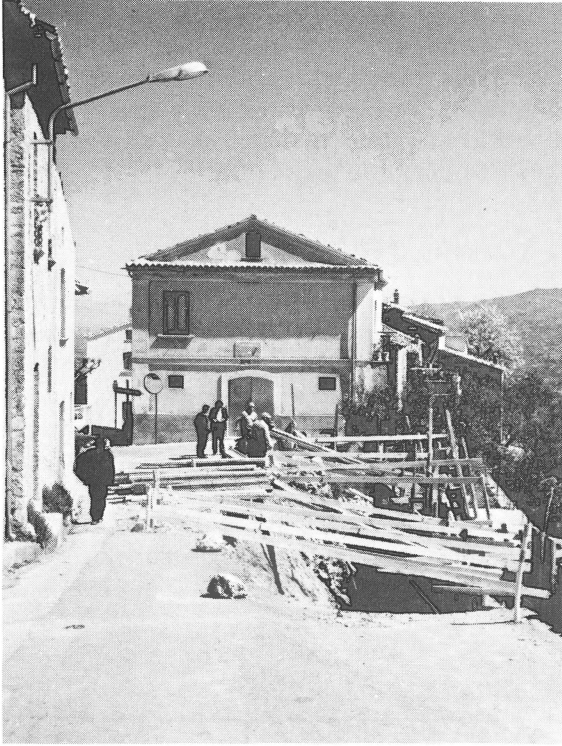
Fig. 12
Head scarp of recent Tessano slide.

The cause of the slope instability is thus made clear; the present slide, though spectacular, is but a small expression of the instability of the slope as a whole and must be seen as the normal continuation of the gradual collapse of this slope. A spring in the slide face may have contributed to the actual motivation of the part.

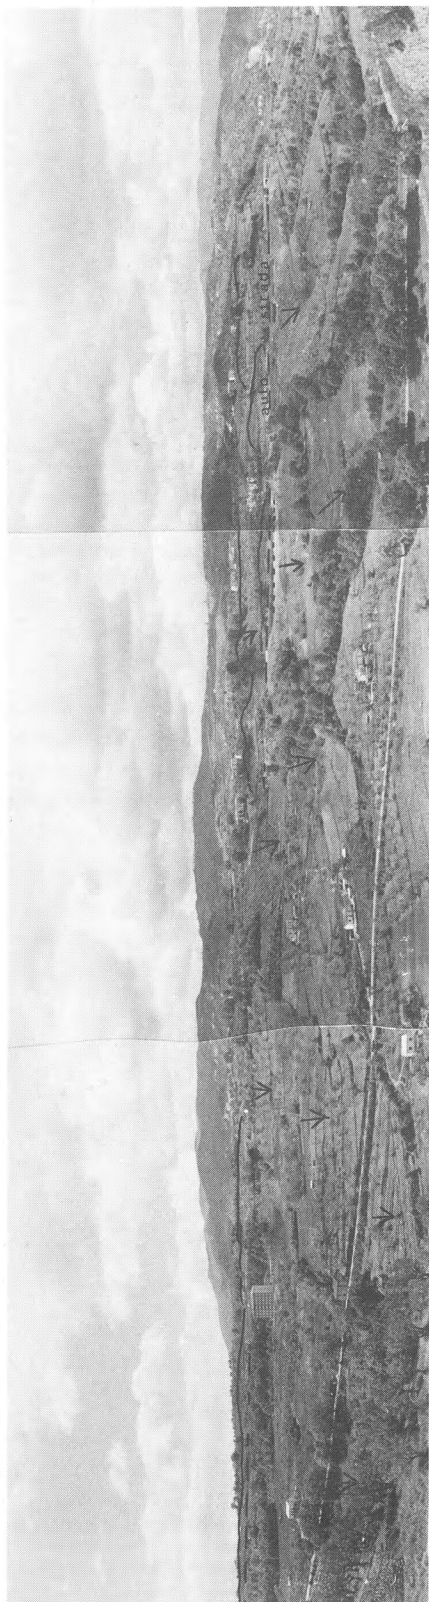
◀ Fig. 14

Panoramic view of slide zone from Donnici village.

In the present zone, water infiltration enhances the slope instability. Signs of sliding on a large scale in the somewhat earlier past are abundant, and the zone is to be considered a dormant slide (fig. 14).

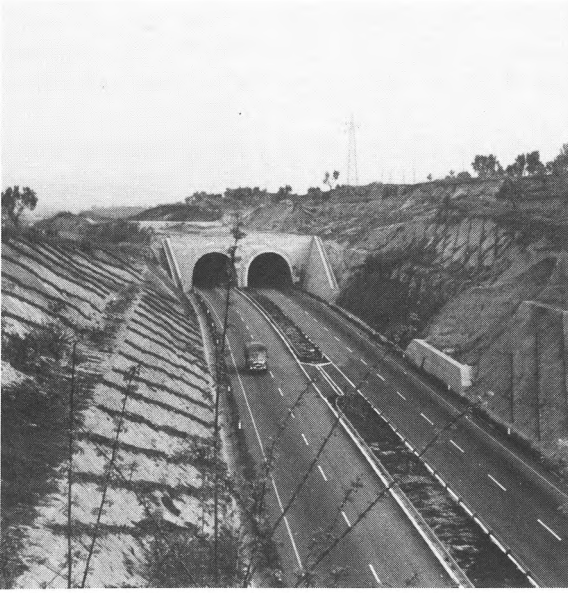
Fig. 15
Roofed gallery to protect autostrada from sliding masses of head scarp.

roofed gallery underneath the head scarp protects a stretch of road about 150 m long (fig. 15); moreover, several minor stabilizing works have been carried out.

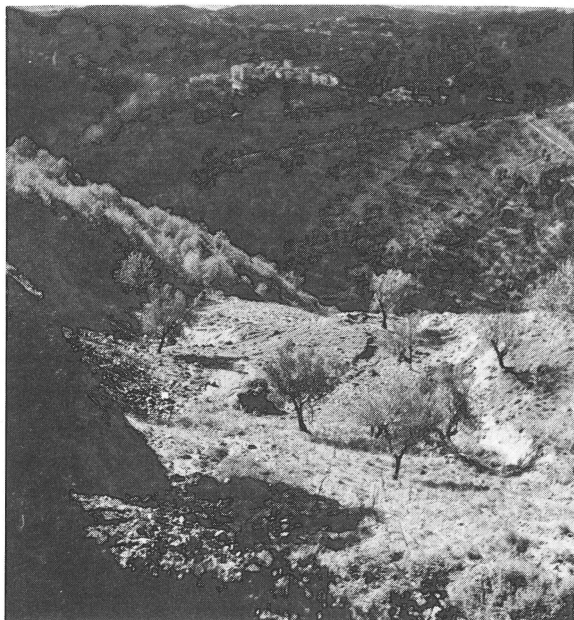
Fig. 18
San Pietro slide, seen from head scarp at Altavilla.

Length: the horizontal equivalent distance, crown to toe, is 240 metres, giving the slid terrain an average gradient of 70%, corresponding to an average slope angle of 35° . It will be noted that the lower part (cf. fig. 17) has a much steeper gradient as it forms part of the gorge. Undercutting at the toe maintains this steep angle. The head scarp is clearly distinguishable, and has near-vertical backwalls (fig. 17, 18).
