The 1992 Roermond earthquake, the Netherlands: earthquake engineering

Jack G. Bouwkamp

Institute of Steel Construction, Technical University of Darmstadt, Alexanderstrasse 7, 64283 Darmstadt, Germany

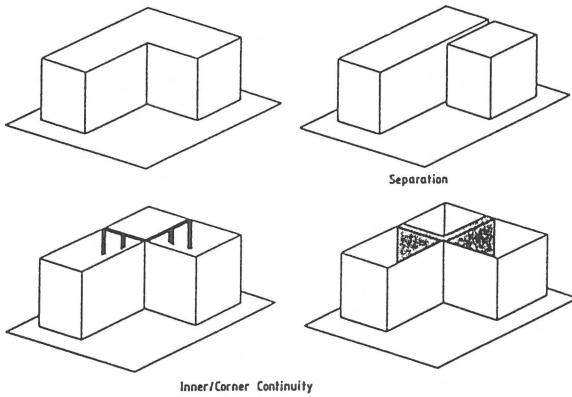
Fig. 2. Examples of asymmetrical buildings (L-shaped).

In general, whenever possible, the floor plan of buildings should be symmetrical in order to prevent structural distress under earthquake. Also, the lateral stiffness should be distributed such as to reduce torsional motion during an earthquake. Hence, guidelines should draw attention to the inherent dangers of buildings with L, H and T-shaped floor plans and stipulate the necessity to give special attention to the structural layout. At the inner corners, the orthogonal load transfer of incoming walls has to be accommodated by providing a structural system which permits a direct transfer of exterior wall forces into the interior of the structure (Fig. 2). The best solution would be a separation of the different portions of such buildings and leaving a sufficiently large distance between the several parts in order to prevent a pounding or hammering effect between adjacent portions under earthquake exposure.

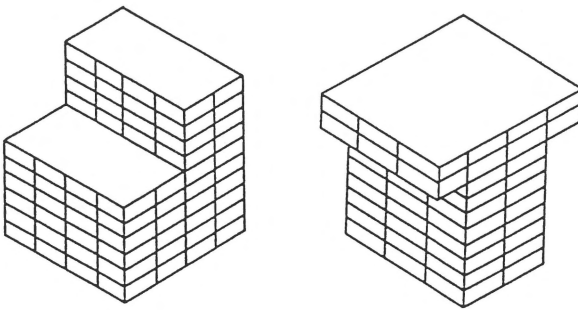
Fig. 3. Examples of irregular buildings (Vertical layout).

Also, buildings with vertical setbacks or cantilevering storeys (single or multiple floors), as shown in Fig. 3, are prone to serious damage under earthquake motion. In case of setbacks (e.g. penthouse) it is essential to assure the structural continuity of the setback portion, through columns or walls, over at least one, preferably more storeys immediately below the setback level. In case of cantilevering storeys, the lateral and vertical-load-resisting elements immediately below the cantilever portion need to be continued upward through that portion. Failure to introduce such structural measures may lead to serious structural damage (either beneath the setback level or in the cantilever storey, respectively).
